Bikes on Buses Trial
April 2016 - April 2017
Report

June 2017

Parry Serafim
Manager Planning & Industry Development
Bus Association Victoria Inc. (BusVic)

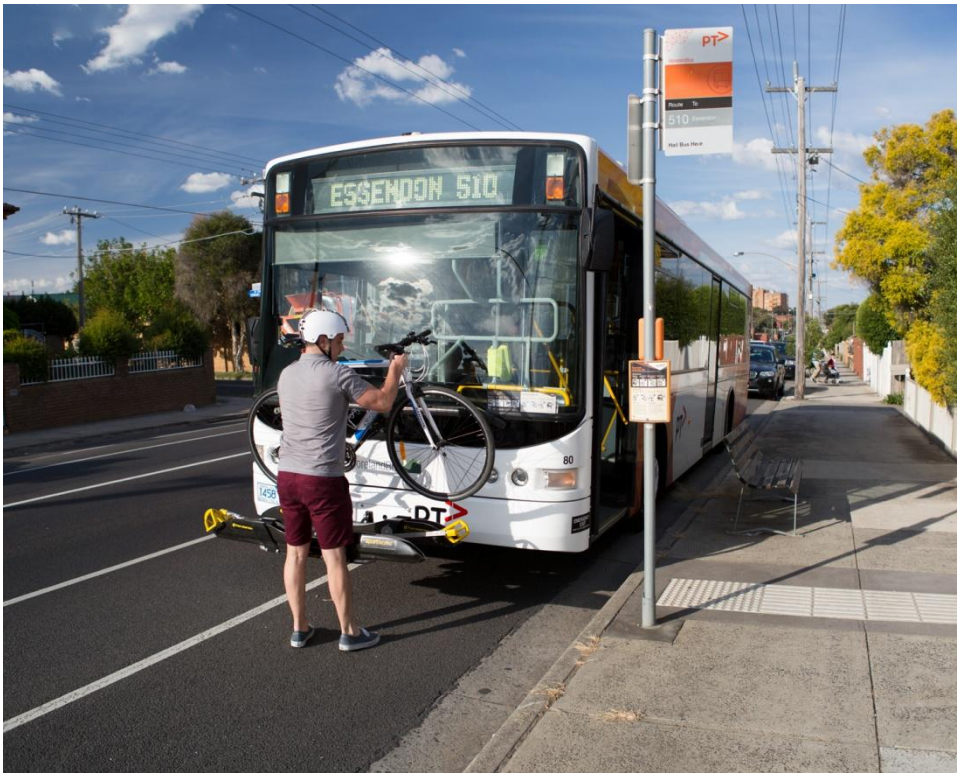
Veloporter 2 Rack loading

The Veloporter 2 rack is an industry standard unit. The unit operates under a simple system where the bike is placed in the rack and a handle is extended and used to clamp the front wheel into the tray. The handle, for new units, is quite stiff and can quickly clamp down when released. Bus drivers observed that some users had difficulty using the clamping device the first time. As users became accustomed to the system, the ease of use improved.

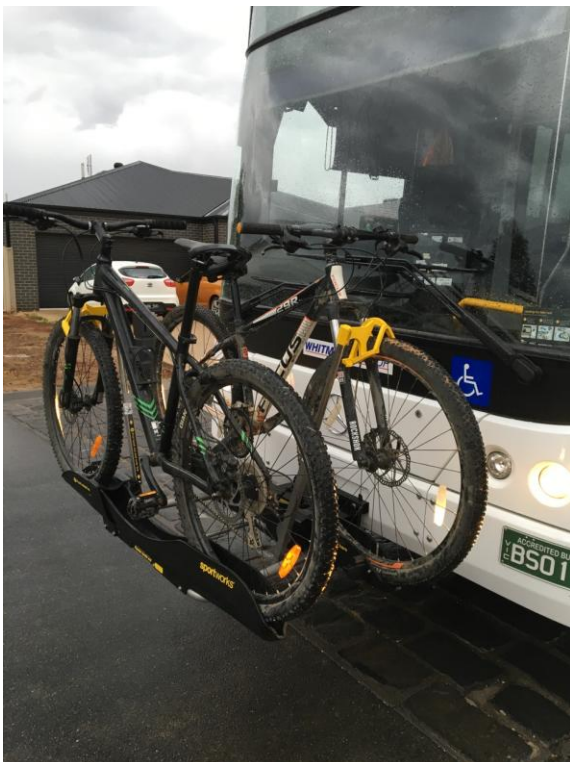
Veloporter 2 Rack in deployed position

The Veloporter 2 bike rack, when loaded with 2 standard bicycles has an overall forward protrusion of 1.2m from the front of the bus. For a typical route bus in Victoria, this creates an overall vehicle length of 13.5m. Computer modelling and on road analysis has shown that buses fitted with the Veloporter 2 rack, and with the rack in the "operational" position, have an on-road manoeuvrability and performance level that aligns with a typical bus in terms of swept path and frontal swing. Section 5 of this report provides further details on the on road performance of the system.
