MONASH
University

**Annual Bus Roadworthy Inspections: Evidence-based assessment
of impact of proposed inspection procedures
on safety and cost**

Report prepared for Road Safety Inspections

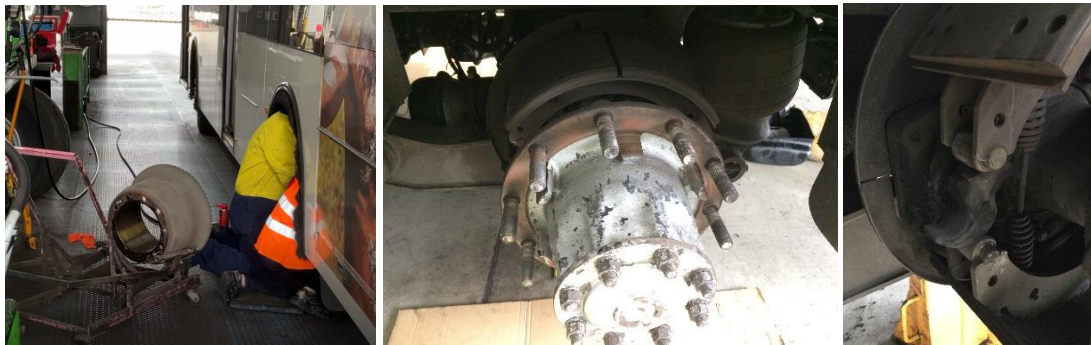
Figure 2-2 Drum brake and wheel maintenance at representative Victorian bus depots

Figure 2-2 illustrates typical drum brake and wheel maintenance at a large Victorian bus operator (Dyson Group).

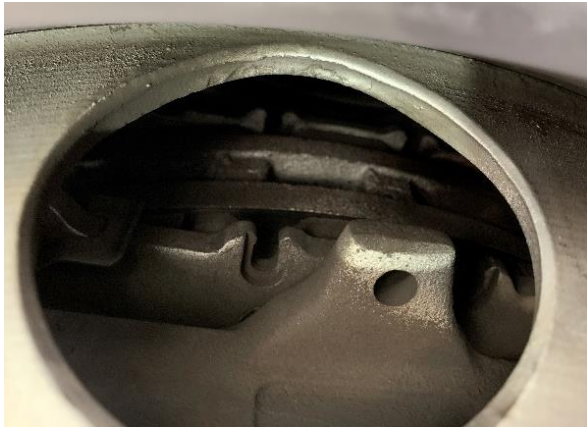
Figure 2-5 View of brake pads wear through wheel rim holes

The linings can be visually inspected through the brake drum backplate inspection cover (peep hole), which is a universal and time-honoured process to assess the state of wear for drum brakes and can detect most brake shoe wear (Dalrymple, 2020). Most disc rotor and brake pads wear can be inspected by looking through the wheel rim holes or from under the bus using a set of gauges, as illustrated in Figure 2-5.

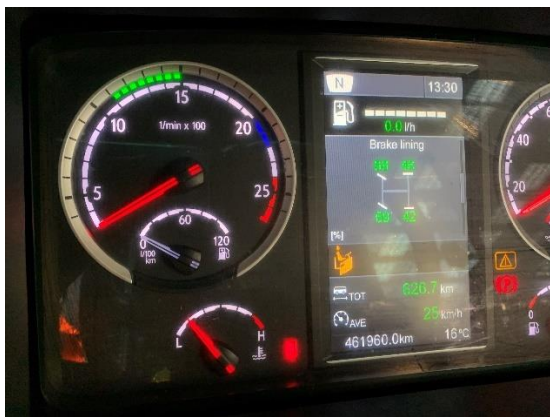
Figure 2-6 Disc brake wear indicators

For disc brakes, an emerging method available for monitoring pad thickness is electronic pad wear sensors. According to Sam Distefano, Group Manager Fleet Services at Dyson, and Brett Gibbs, General Manager at Road Safety Inspections, most modern vehicles are fitted with disc brakes at the front and rear and have brake pads wear sensors to indicate brake pad wear (roughly 2010 onwards). There are generally two different types of pad wear sensors, one with a simple on/off switch that illuminates a warning light on the dash panel when the pads need changing (end-of-life sensor), and the other with a continuous wear sensor providing feedback to the vehicle's electronic control unit throughout the pad life (potentiometer sensor) (American Public Transportation Association, 2017a). In view of the shift to disc brakes during the last decade and years to come, pad wear sensors may be a useful tool to monitor wear and brake friction material.

With wheels staying on, the pad thickness can be inspected by reading the visual indicator (mark) or at the vehicle's electronic control unit fed by the pad wear sensor.

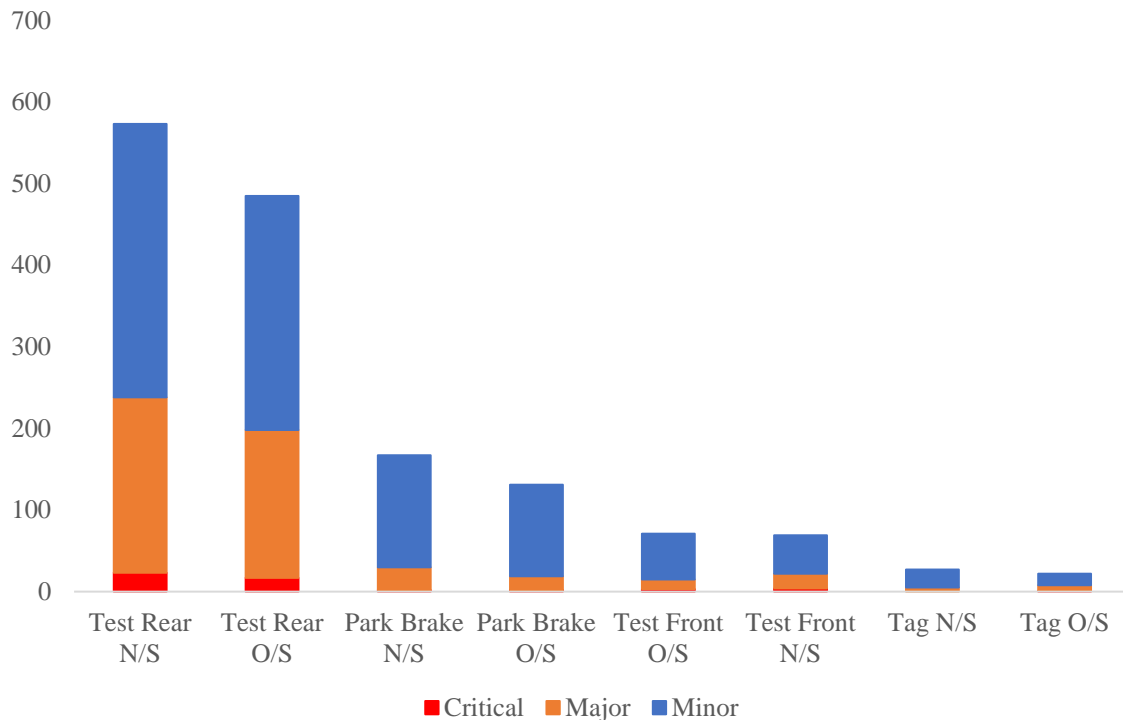
Figure 3-1 The distribution of failures among Brake Performance by fault type and severity

First, the number of failed Brake Performance was examined. Among the 61,644 bus inspections RSI conducted between 2011 and 2020, 1,225 (2.0%) failed Brake Performance and the distribution by wheel position and severity of failure is shown in Figure 3-1. Approximately half (46.8%) of those that failed Brake Performance had issues with rear near side brakes and around 40 percent were rear off-side brakes. The finding that the most prevalent brake inspection failures were with rear brakes is consistent with the incident data that rear brakes were more prone to break down.

Inspection wise, around four percent of the inspections failed Service Brake and air leak was the most common defect (accounting for 50.2%). Around two percent of the inspections failed Brake Performance and issues with rear brakes were the most prominent (46.8% near side and 39.6% off side).

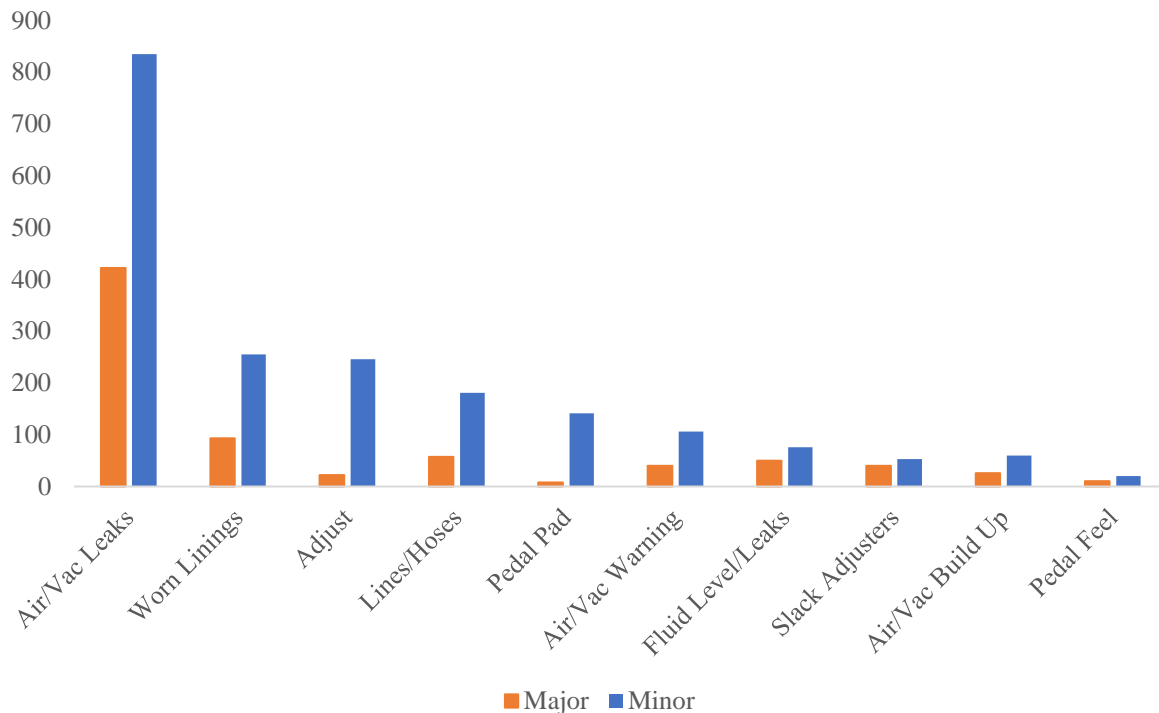
Figure 3-2 The distribution of failures among Service Brake by fault type and severity

In addition, the frequency of failures among Service Brakes was examined and the distribution of these failures by fault type and severity of failure is presented in Figure 3-2. During the 10-year span, 2,504 (4.1%) of the inspections failed Service Brake, among which, 50.2 percent had issues with Air/Vac leak, making it the most prominent brake defect. This finding is consistent with the quote from Sam Distefano, Group Manager Fleet Services at Dyson that the common brake defects that contribute to bus in-service breakdowns and incidents are air leaks and self-adjusting mechanisms failing at times.

Only five critical failures were found, for air/vac leaks and lines/hoses (1 each) and slack adjusters (n=3).

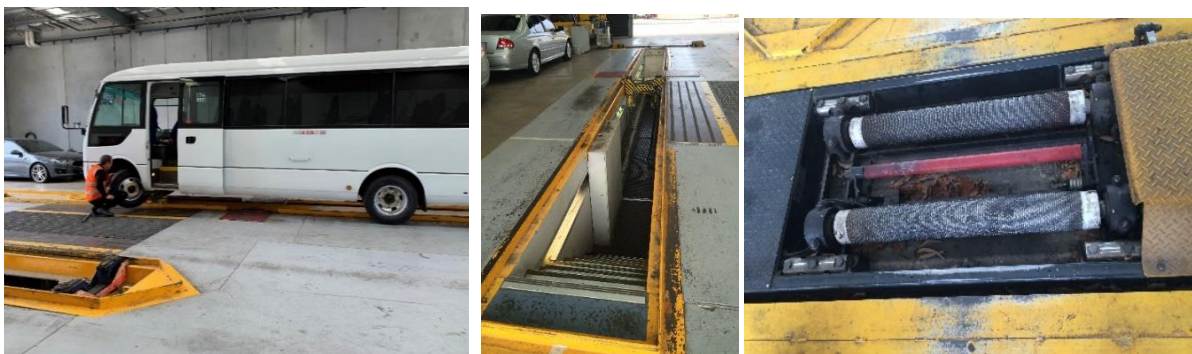
Figure 3-3 Current wheels-on inspection procedure at RSI

Current practice at RSI is to inspect brakes and brake performance with the wheels on, unless there is reason to suspect a defect or poor performance. Inspections with the wheels on is a relatively straight-forward process, and conducted using pits. The inspection can be described as ‘qualitative’ and, as noted in previous sections, the design of the wheels and brakes allows an appropriate visual inspection to be conducted. Figure 3-3 illustrates the current wheels-on procedure at RSI.

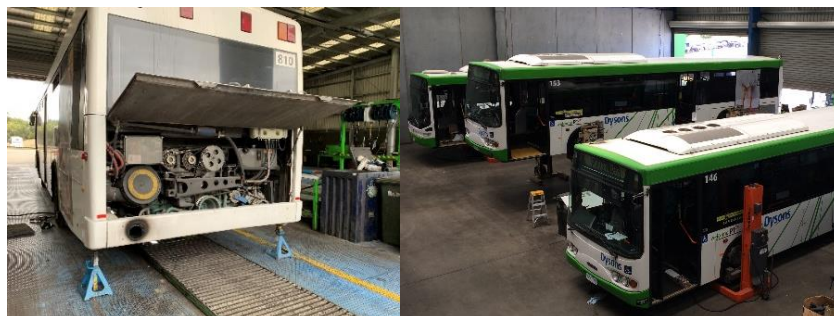
1. Park the bus at a service bay with under-bus access (equipped with a pit or hoist), support the bus on jack stands and jack the bus up to create a gap between the tyre and the ground.
2. Release the parking brake.

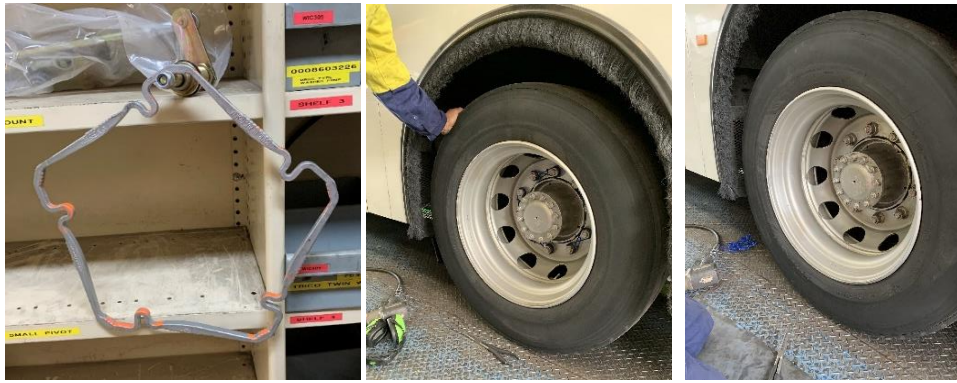
1. Remove the RipClips or Squirrel on rear wheels

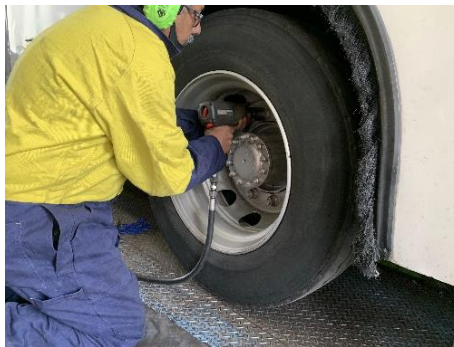
2. Loosen the wheel nuts using the impact gun

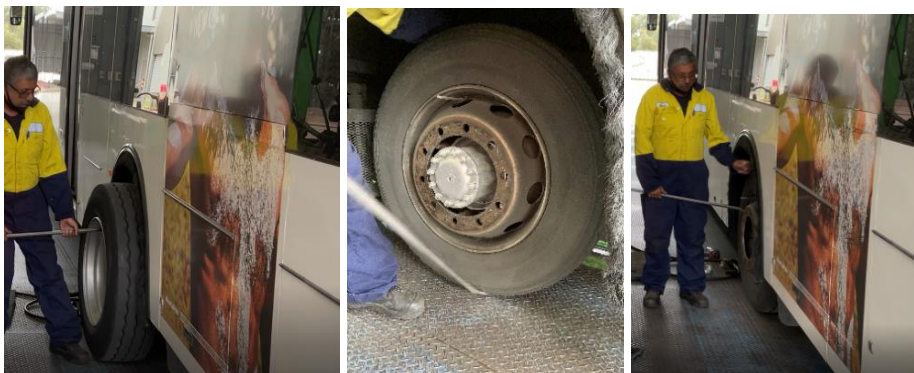
3. Pull the wheels off with a lever

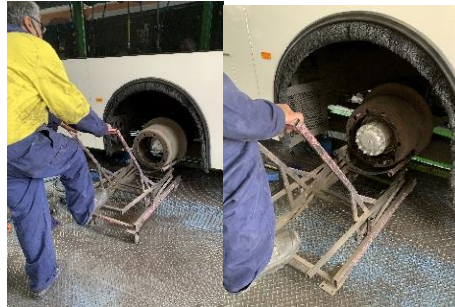
6. Use a lifting device (wheel hoist trolley) to pull off the brake drum

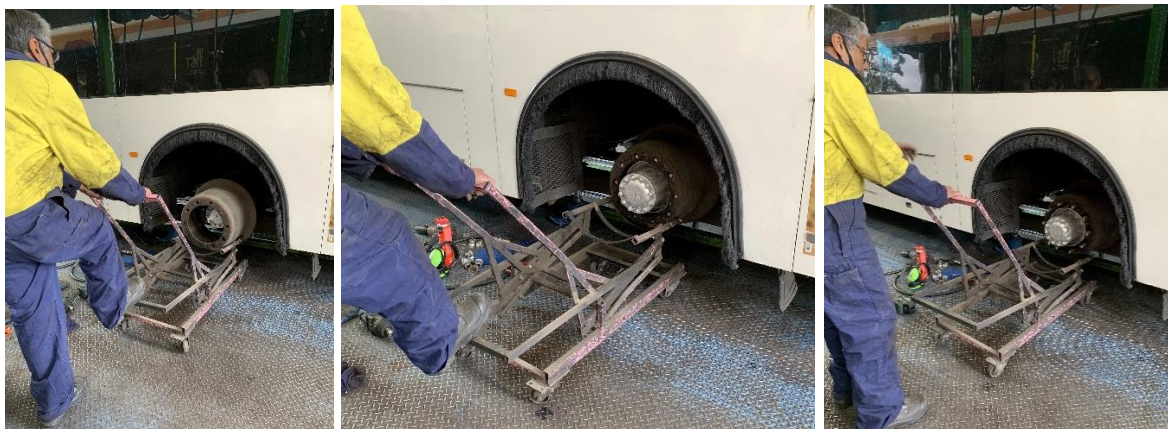
1. Put the drum back on

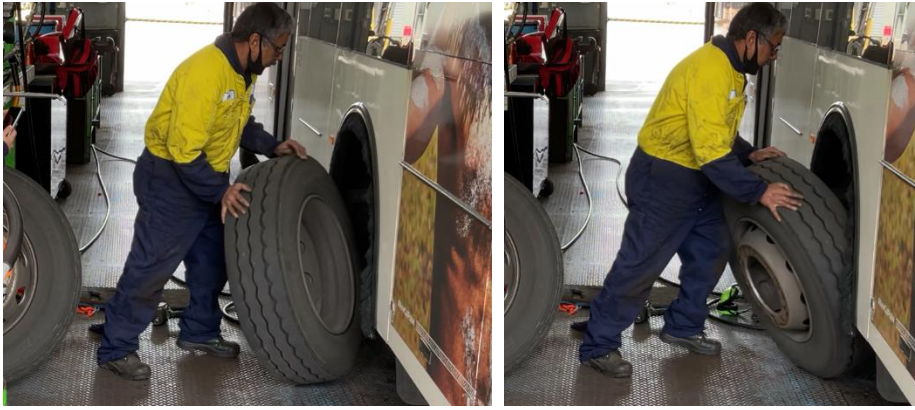
2. Put the wheels back on

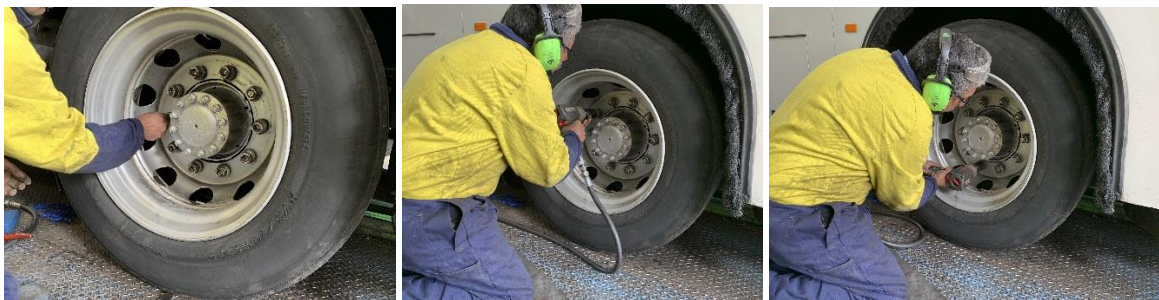
3. Screw the wheel nuts

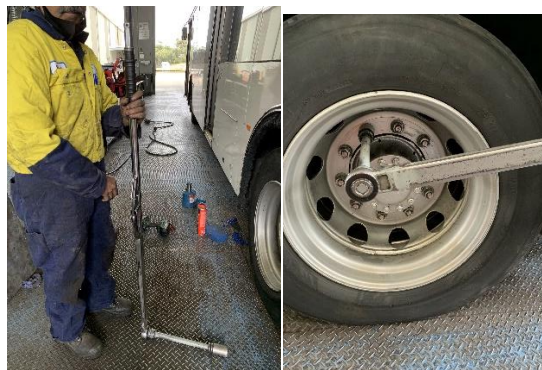
4. Use a calibrated torque wrench to tighten the wheel nuts to the correct torque, as specified by the manufacture.

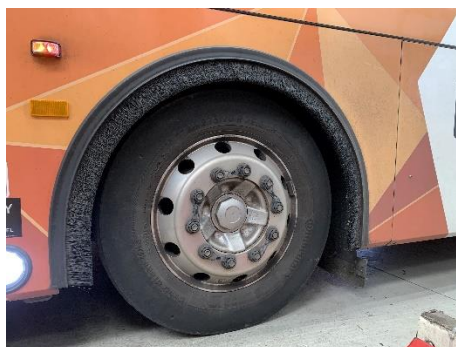
1. Remove the RipClips (if applicable)

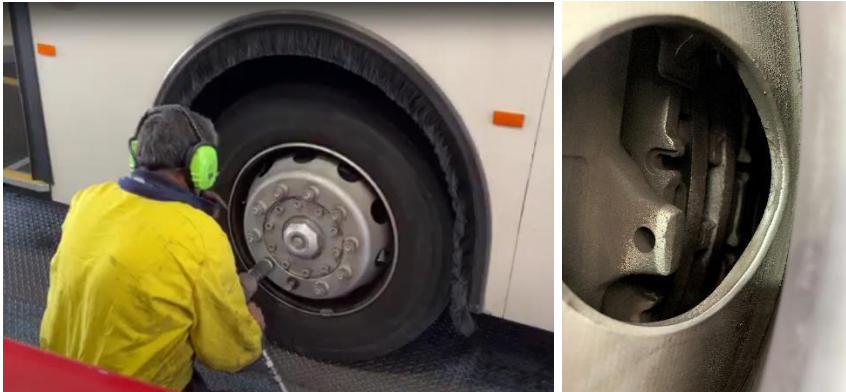
2. Loosen the wheel nuts using impact gun

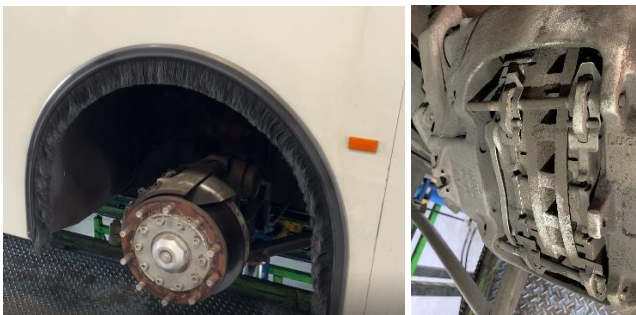
3. Pull the wheels off with wheel hoist trolley

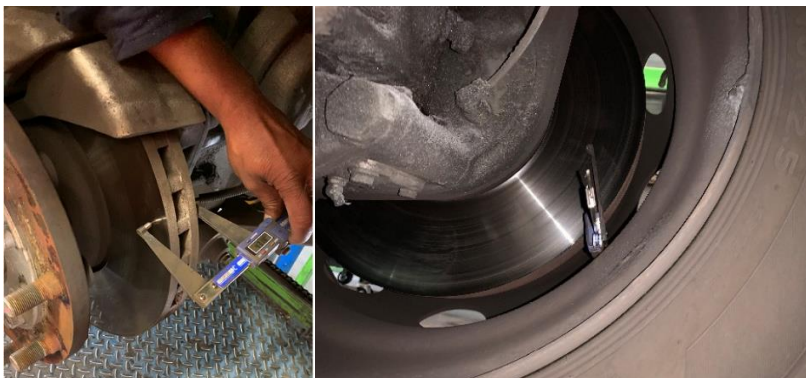
1. Measure the rotor thickness using vernier caliper (digital).

The measurement can be achieved from underneath the bus, without dismantling the wheel.

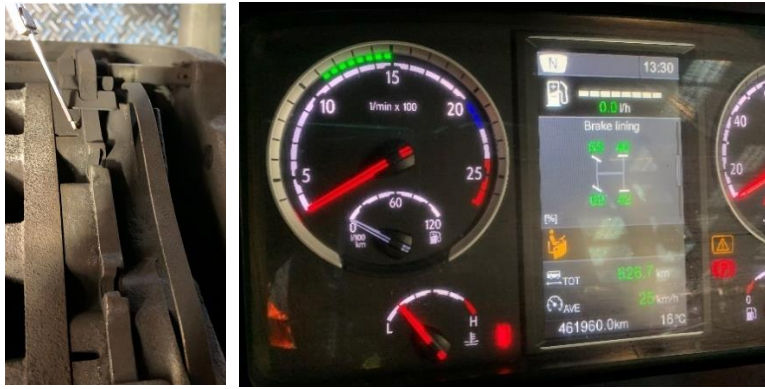
2. When wheels are removed, pads can be measured directly to achieve an accurate pad thickness measurement.

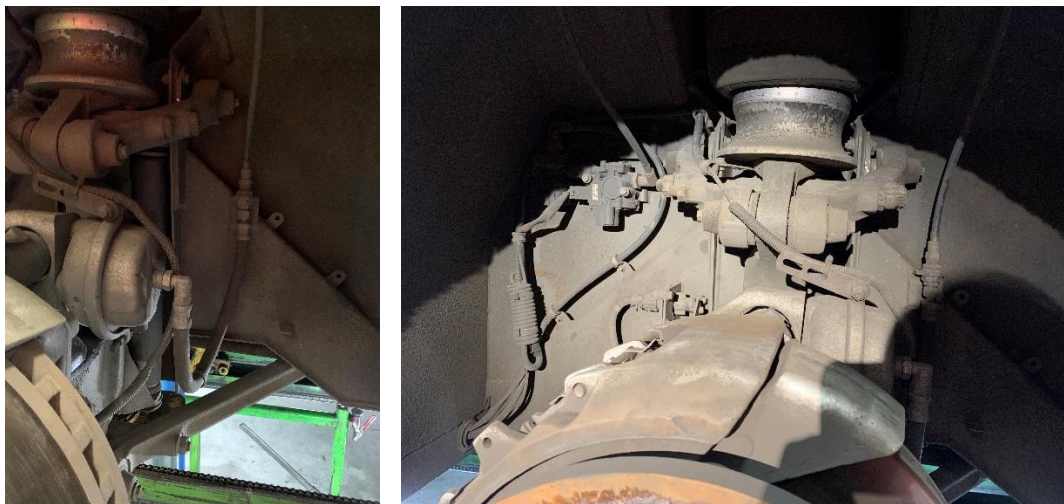
3. Inspect brake lines and hoses

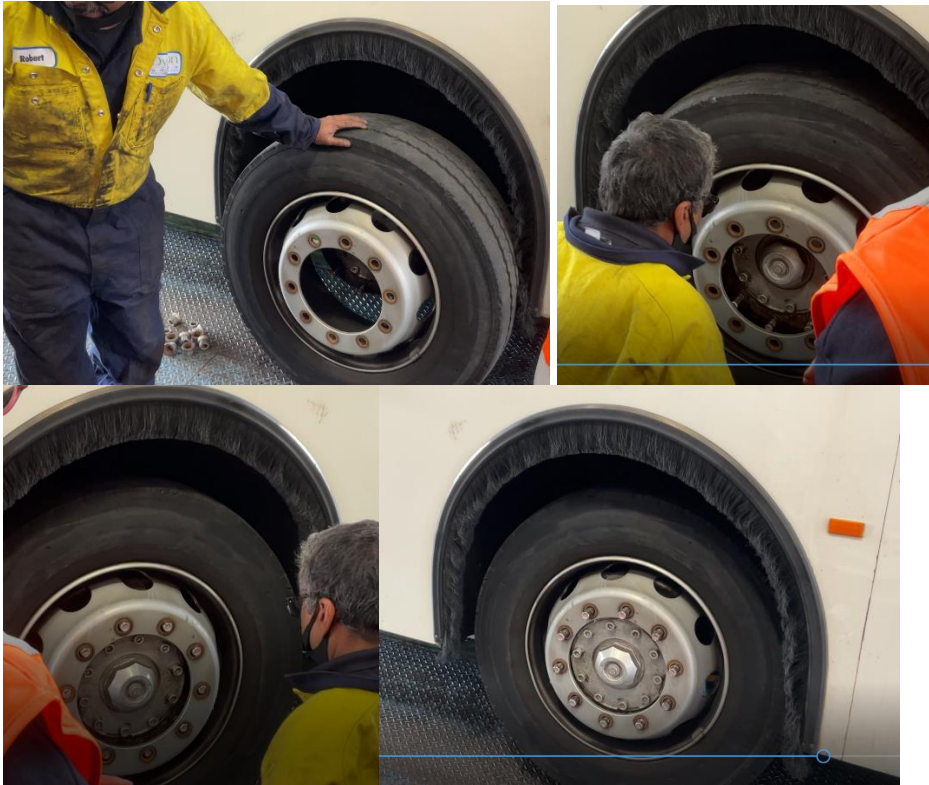
1. Put the wheels back on

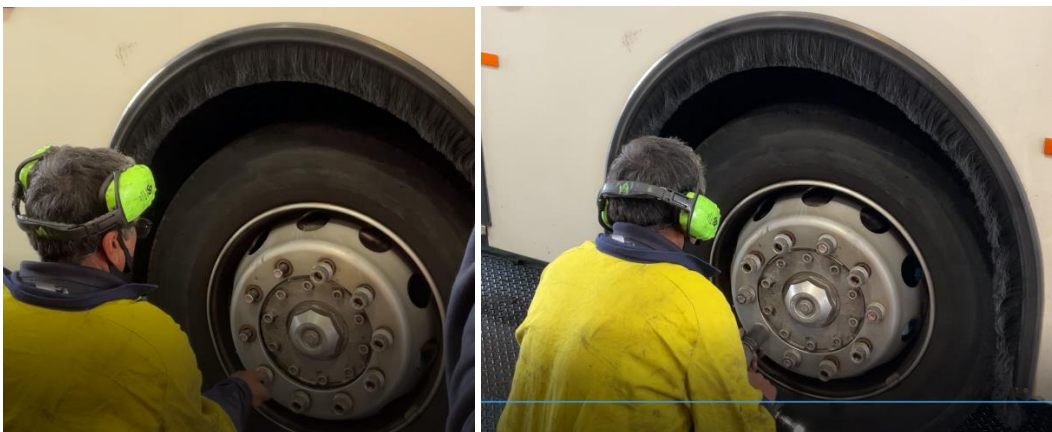
2. Screw the wheel nuts

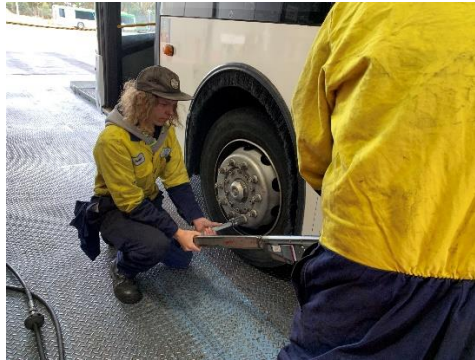
3. Use a calibrated torque wrench to tighten the wheel nuts to the correct torque, as specified by the manufacture.

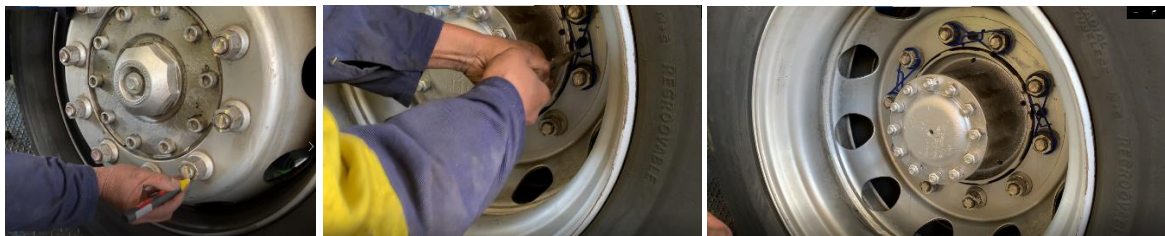
Take a road test and retention the wheel nuts

Following wheel disassembly and assembly, the bus is required to take a road test, travel a certain distance, depending on manufactures' recommendation (e.g. up to 500kms), then return to the workshop for wheel nuts re-tension. Following that, nut markings need to be repainted and wheel nut locking devices be fitted.

A road test and the consequent torque check (retightening wheel nuts) following the wheel change is an important aspect in ensuring proper clamping force on wheels. A low clamping force by the wheel studs and nuts leads to nut detachment or stud fatigue fracture. Therefore, a torque check is essential in preventing wheel separations on buses (Bailey & Bertoch, 2009), which can have tragic results when these heavy wheel assemblies (between 70 – 90 kg) collide with other vehicles, people, or roadside objects (Bailey & Bertoch, 2009; Monster & Eng, 2004). There were nine reported incidents involving loose wheels, wheel nuts and wheel detachment during 2012-2018 in Victoria (see Appendix F for details).

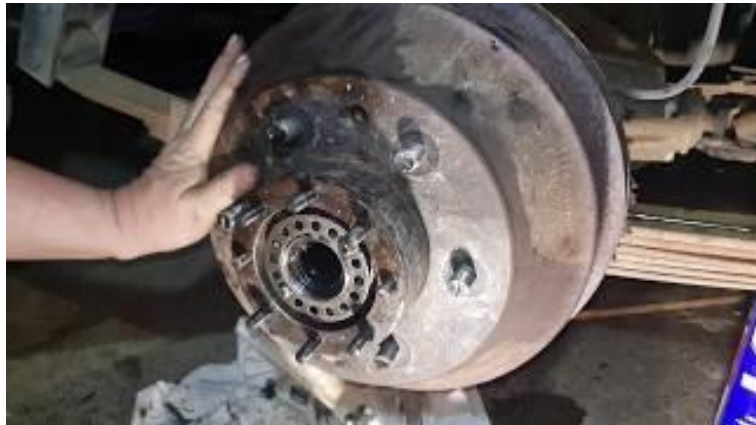
Figure 3-3 Structure of Toyota Coaster rear drum brake.

It is worth noting that the above demonstrates the most typical brake structures in the Victorian bus fleet. For some medium-sized buses, the task of rear wheel disassembly and assembly is associated with increased complexity, including removing the hub and the drum assembly, ensuring correct replacement of wheel bearings, and associated issues, therefore require more time, and generate the need for additional training. An example is the Toyota Coaster. The dual wheel setup, nut surfaces that contact the rim and wheel bearings are complex structures that requires substantial effort to remove and re-assemble the wheels. An example of the Toyota Coaster drum brakes structure is provided in Figure 3-3 below.
