Victoria walks

Getting to the Bus Stop

September 2021

This report was prepared by Josephine Eady and Duane Burt (Victoria Walks). It was funded by Bus Association Victoria.

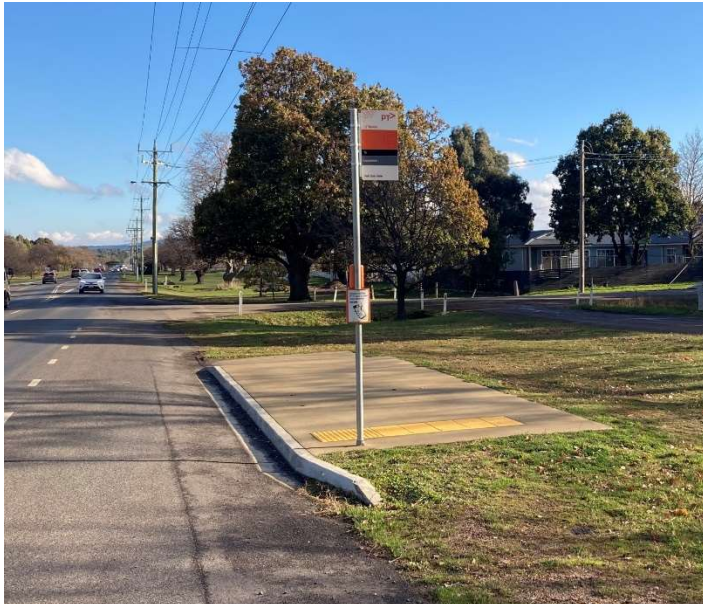
Figure 4 A new bus stop in Riddells Creek which appears to comply with the Standards, but is not accessible to everyone as it has no connecting footpath

with the technical requirements set out in the Transport Standards, to creating a continuous accessible path of travel for people with disabilities.” Likewise, the Victorian Council of Social Service (2011) also recognises the distinction that compliance is about obligations of agencies to meet the Standards, whereas accessibility is about the outcome so that people can actually use the system.

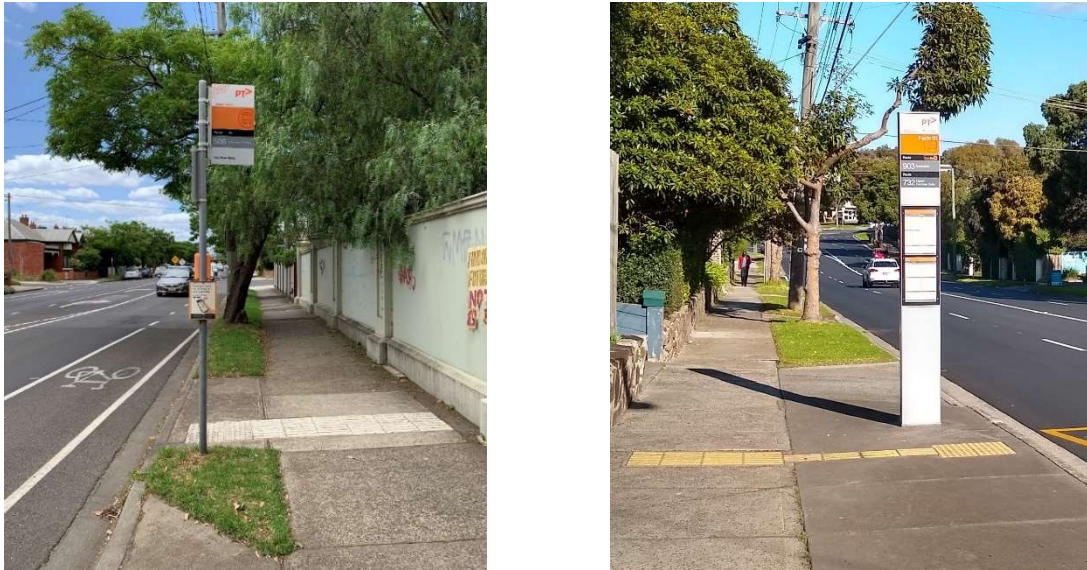
Figure 7 A bus stop in Northcote identified by a flag (left) and a bus stop in Box Hill identified by a totem (right)

It is important for people to be able to identify where the bus stop is, especially for people and bus drivers unfamiliar with an area or bus route. Bus stops in Victoria are generally marked by signs on steel poles (called flags) or sometimes totems, both shown in Figure 7.

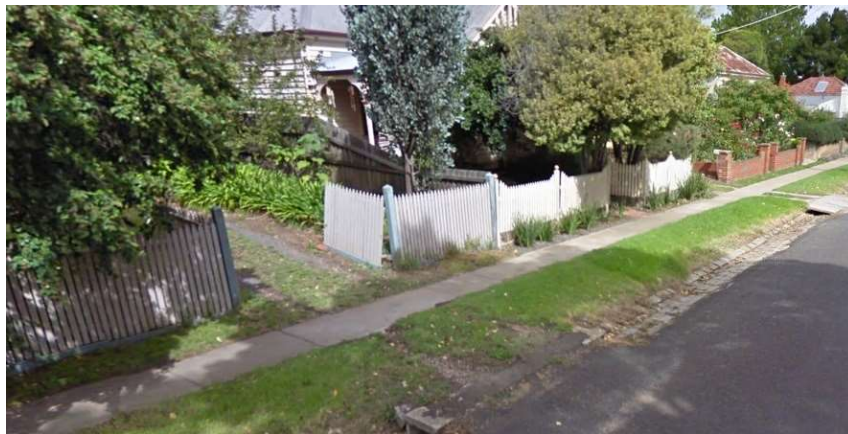
Figure 8 This location in Castlemaine is identified on the PTV website as a bus stop, but has no identifier
(Image source: Streetview, Google Maps, March 2010)

Some bus stops have no identifying features to inform people that it is a bus stop, such as that in Figure 8. This could be because:

- the stop has never had a flag or totem,
- the flag is missing, for example knocked over by a driver or temporarily removed during roadworks, or
- the stop is not in use anymore.

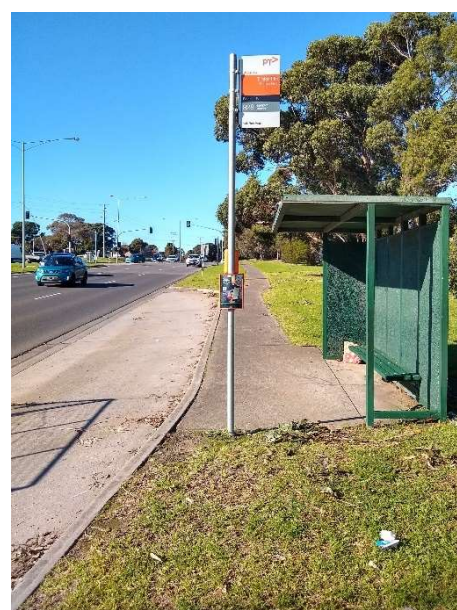
Figure 10 A kerbside bus stop in Warragul (left) and an indented bus stop in Narre Warren (right)

There are two main types of bus stop used in Victoria, kerbside and indented, shown in Figure 10. Kerbside stops generally require traffic to wait behind the bus, while indented stops mean the bus must pull out of the traffic and then back in.

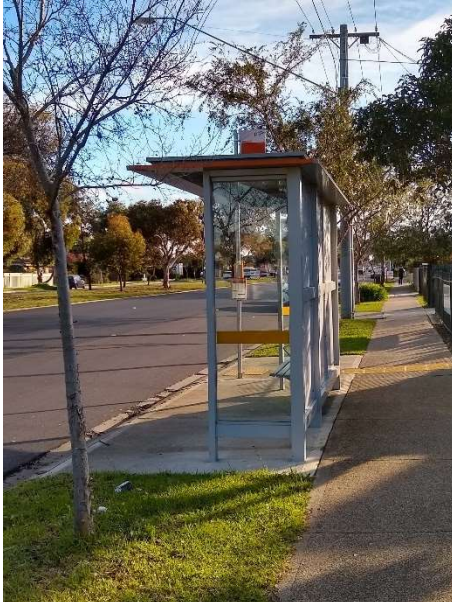
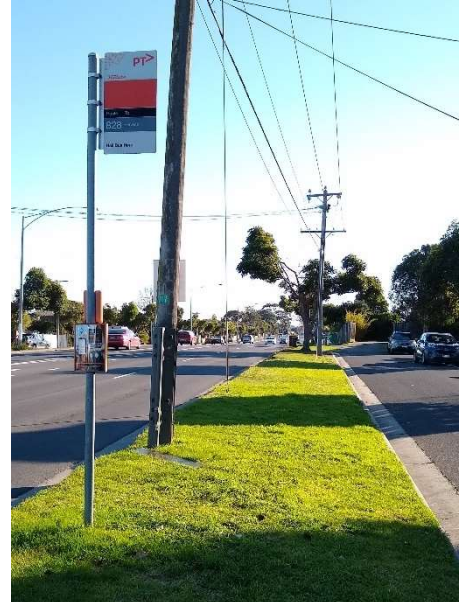
Figure 12 A bus stop with concrete surface in Hoppers Crossing (left) and one with a grass surface in Cheltenham (right)

A bus stop located on concrete generally provides an even, firm surface and tends to be less slippery and muddy than grass or soil when wet (Figure 12).

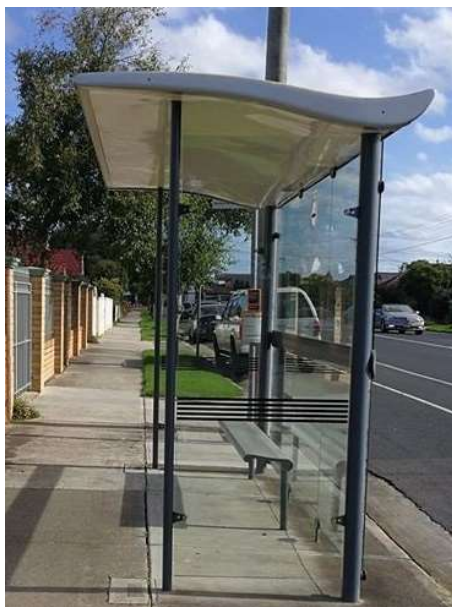
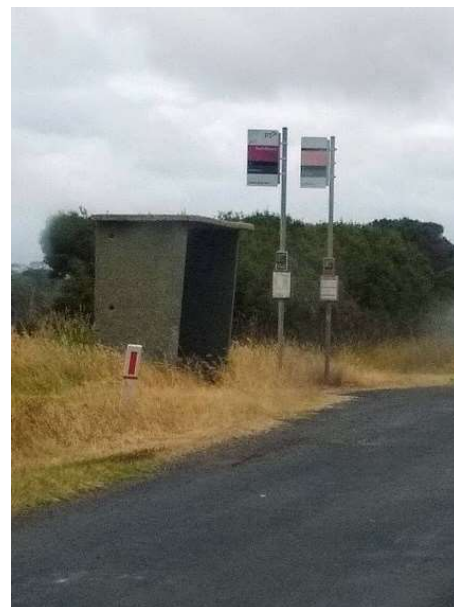
Figure 14 A transparent bus shelter in Pascoe Vale (left) and an older style, opaque shelter in Surf Beach, Philip Island (right)

The design of bus shelters has improved over time, with newer, transparent shelters allowing both the person sitting in the shelter to see an approaching bus and the bus driver to see and hence stop for the person waiting. They also provide better passive surveillance.

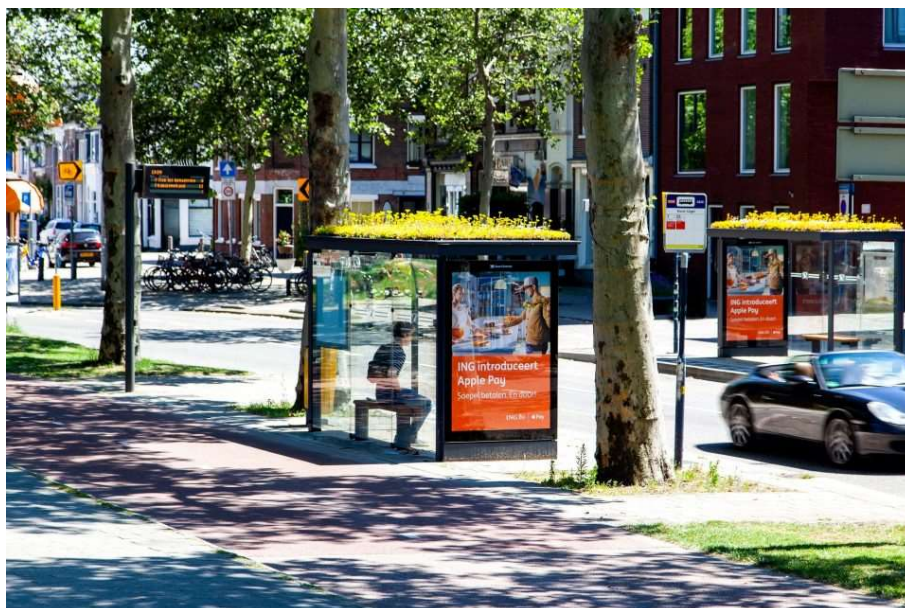
Figure 15 Bee friendly bus stops in Utrecht, Netherlands (Image source: Steffen, 2019)

Cities internationally are finding innovative ways to better incorporate bus stop shelters into the public space. Utrecht, Netherlands and Leicester, UK have both installed green roofs on their bus stops with plants chosen specifically for their attractiveness to bees. As well as helping address declining bee numbers, they can also reduce the urban heat island effect, absorb rainwater, clean the air and beautify the city (Hirsh, 2019; designboom, 2021).

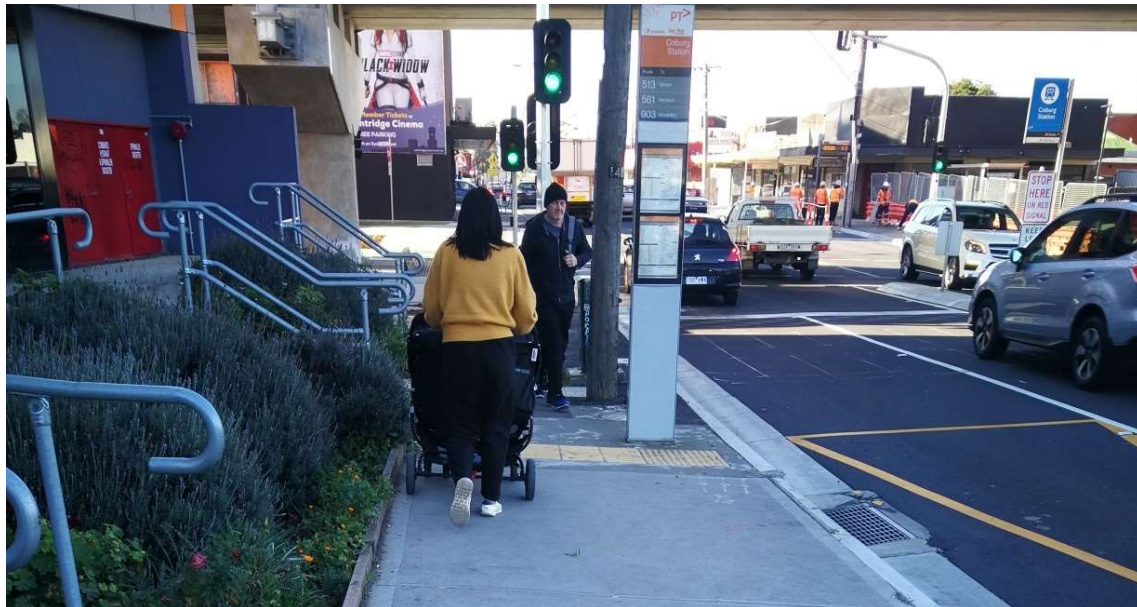
Figure 18 There is limited space for people walking past or waiting at this bus stop on Bell St, near Coburg station

The infrastructure provided at bus stops influences the broader walking environment, including how easy it is for people to get to, move around and walk past the stop. Bus shelters, bins, trees and poles can create obstacles in the walking network and for accessing the bus, especially for people trying to manoeuvre wheelchairs, mobility scooters or prams. The majority of survey respondents (82%) reported that there was sufficient space for others to walk past the bus stop, although some pointed out that it depends on how many people are waiting and how many people are walking past.

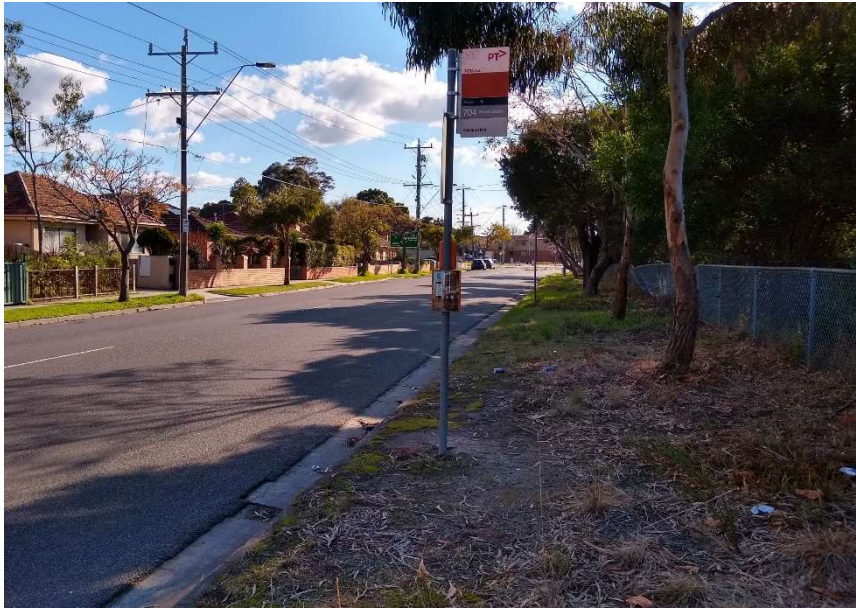
Figure 28 A bus stop adjacent to the train line in Oakleigh South without any footpath

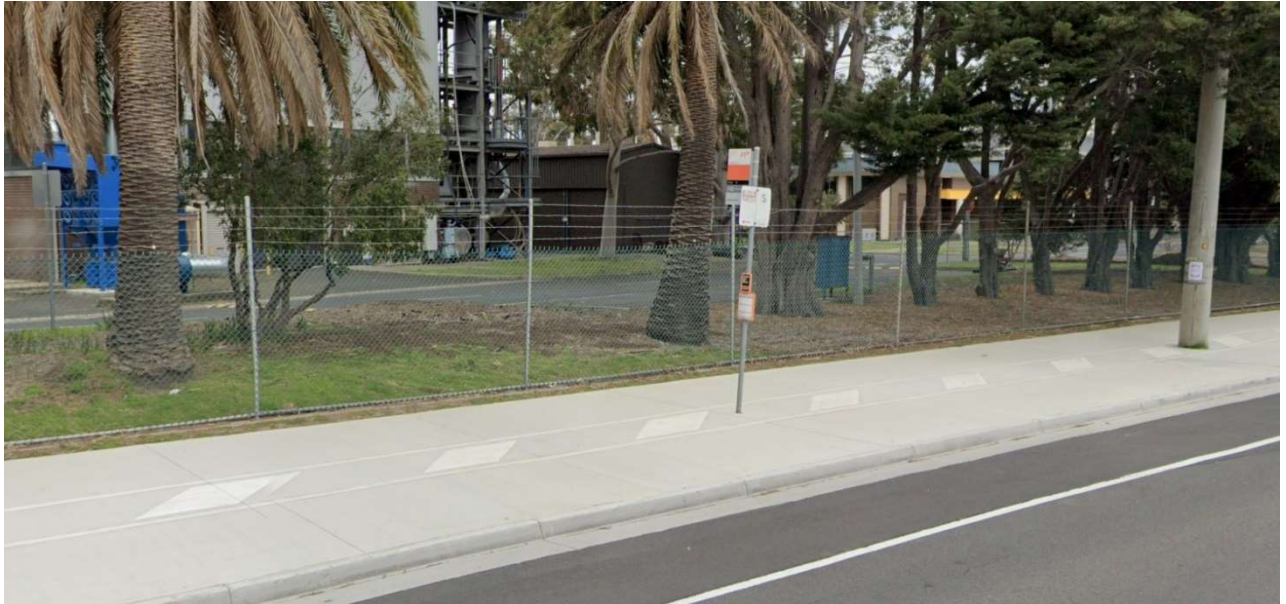
*Figure 30 This bus stop in Notting Hill near Monash University is in the middle of a shared path
(Image source: Streetview, Google Maps, September 2019)*

One bus stop was in the middle of the two directions of a shared path with very little space for people to stand while waiting for the bus (Figure 30). There were a further two audit locations where the path was not signed or marked as a shared path, but people were observed cycling on it.

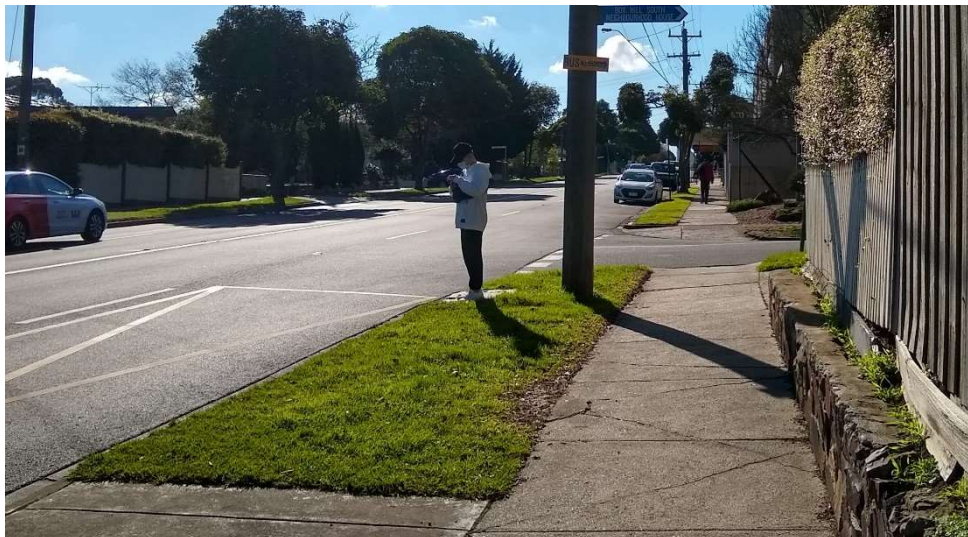
Figure 37 A person waits to cross an arterial road in Box Hill to access the bus stop on the opposite side rather than walking 200 metres to the signals and back

Simply having signals is not sufficient, with users reporting that the crossing was not safe, was too far away or was confusing to use. Many people were observed crossing a road at the bus stop rather than walking to signals, such as the person in Figure 37. This was not only young, fit people either. In one case, an older couple chose to cross a four-lane, 60 km/h undivided arterial to access the bus stop rather than walking to the signals 180 metres down the road. Although qualitative rather than quantitative, these observations support the assertion that people will not go far out of their way to use signals in crossing a road.

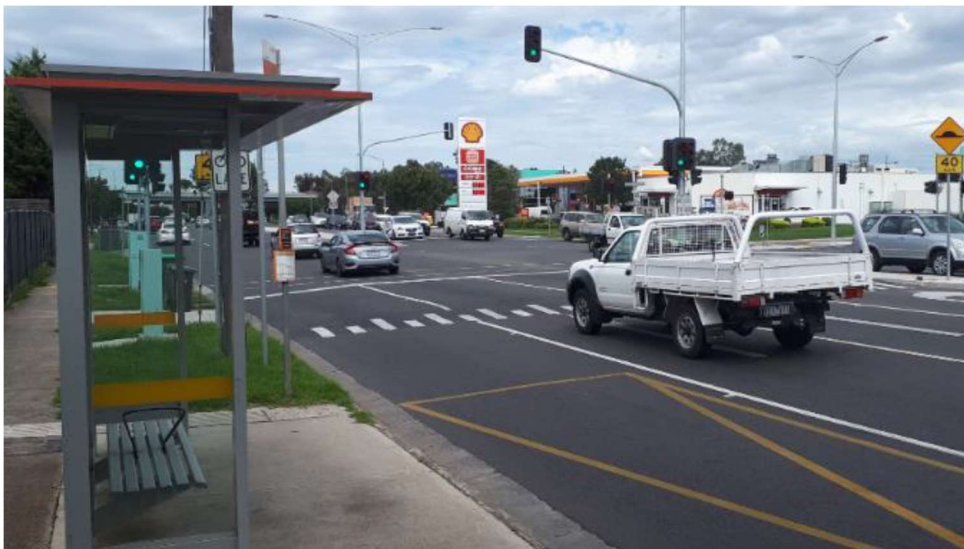
Figure 38 Raised safety platforms on Dalton Road, Thomastown (Image source: Blewden, Mackie, & Thorne, 2020)

Raised crossings (also referred to as raised safety platforms) have been installed at limited locations in Victoria, both at midblock zebra crossings and signalised intersections on arterial roads. They have primarily been installed to slow drivers, improving safety for everyone (Blewden, Mackie, & Thorne, 2020). In addition, they make walking easier as they provide a flush path of travel. Some have been trialled at intersections where the approach roads have speed limits of 60 km/h, such as Dalton Rd in Thomastown (Figure 38) and Plenty Rd in Whittlesea.

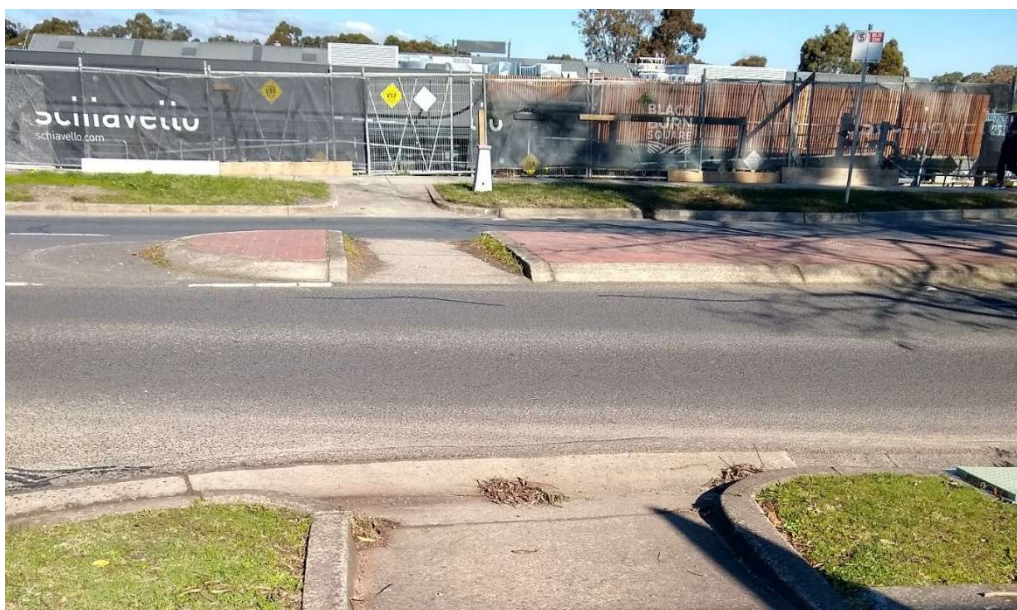
Figure 42 This bus stop in Springvale is adjacent to the Crematorium and there are no kerb ramps or driveways to help people using wheeled devices or with limited mobility to cross the road

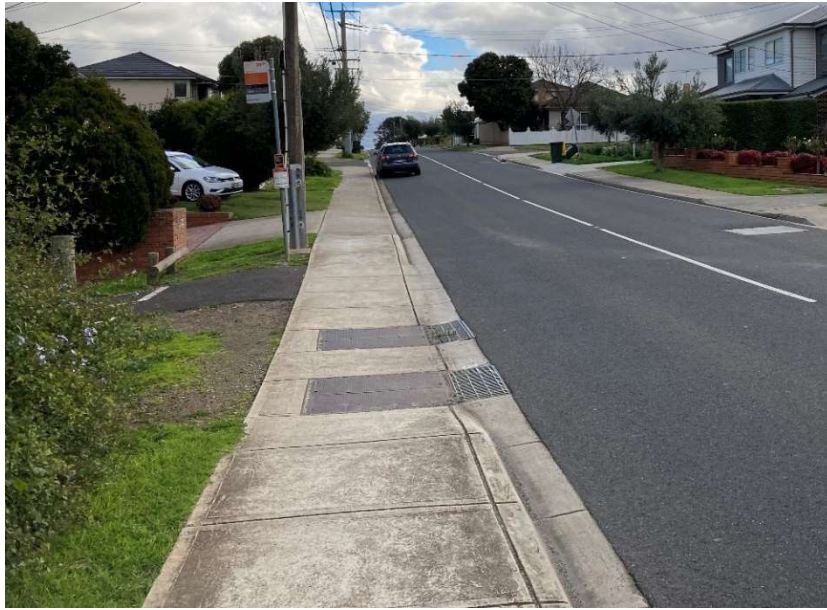
Figure 43 This footpath next to a bus stop in Airport West changes grade at the driveway

At 23% of stops there were no kerb ramps but there were driveways which people using wheeled devices or with limited mobility would have to use to cross the road. Crossing at driveways is not often direct, as they are built for property access rather than to assist people crossing the road. In some new developments in the outer suburbs, the continuation of mountable kerbs at driveways means not everyone can use them to cross the road. There is also the issue of footpaths which change grade at driveways to provide vehicle access, as in Figure 43.

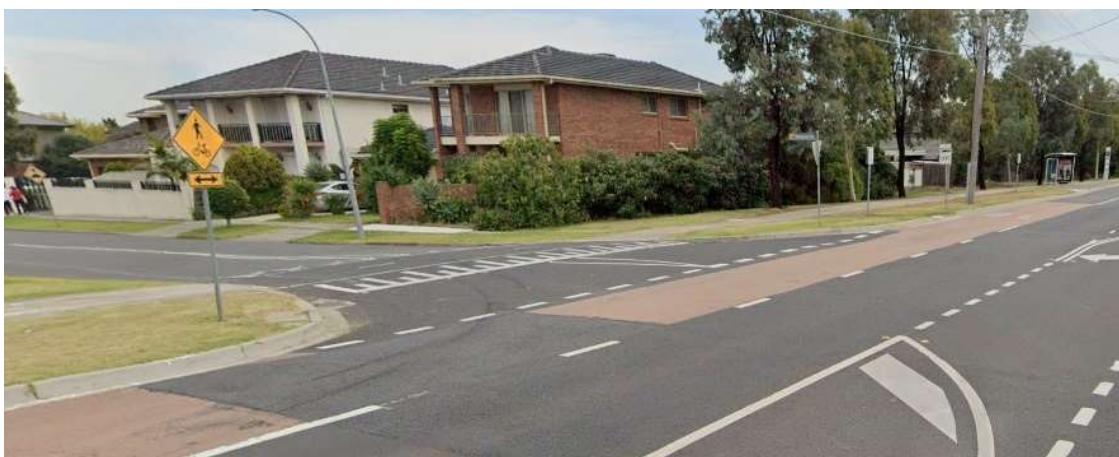
*Figure 44 This shared path in Avondale Heights remains at a constant level across the side street
(Image source: Streetview, Google Maps, March 2021)*

An alternative to kerb ramps is to raise the level of the road to be the same as the footpath, called raised thresholds or continuous footpaths. There were only two examples of this in the bus stop access audits; one in the CBD across a very low trafficked laneway and the one shown in Figure 44 where a shared path continues across the side street at path level (although with no additional obligations on drivers to give way to path users).

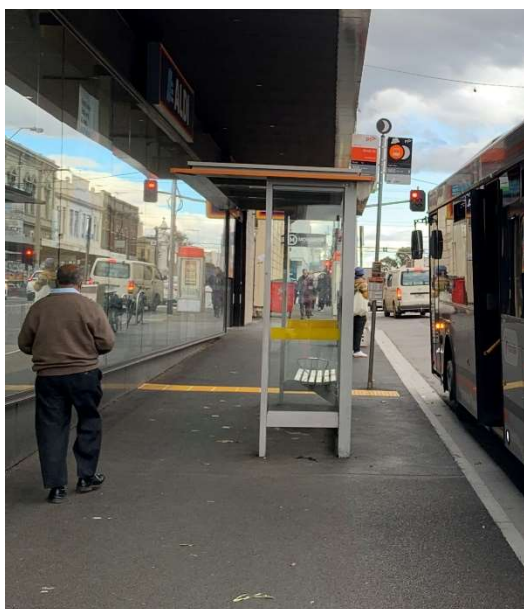
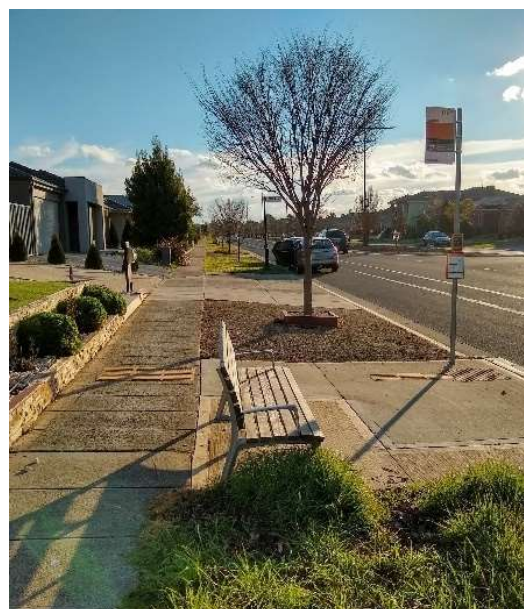
Figure 48 Stops with good visibility – (left) transparent bus stop shelter in Collingwood provides excellent visibility for people waiting as well as walking past; (right) bus stop in Tarneit with excellent visibility for people walking and waiting as there are no power poles and low front fences

- Newer bus stop shelters tend to be clear with good visibility (Figure 48), although marbling, advertising and condensation on shelters were all observed during the access audits. Older styles which cannot be seen through are particularly limiting for visibility. In some cases, people would choose not to use the bus shelter because they can't see through it.

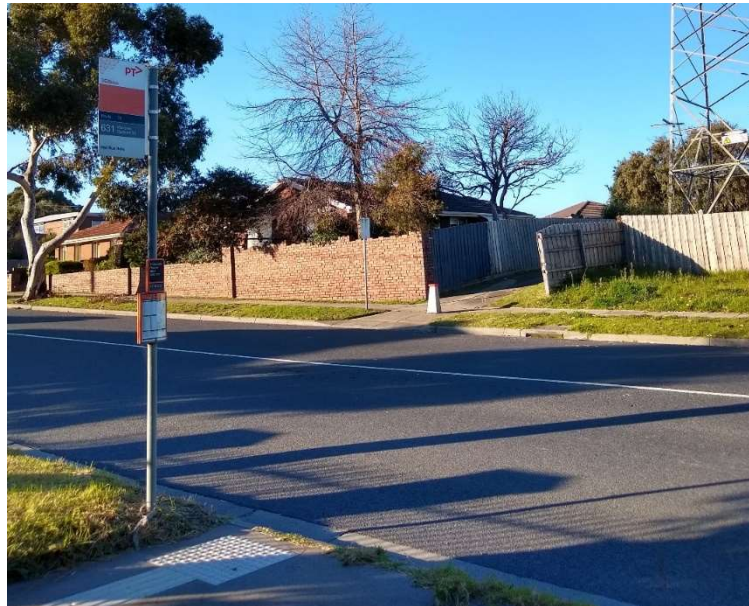
Figure 49 High, opaque fences and high-speed traffic at this bus stop in Clarinda limit passive surveillance

- Vehicles parked along the road can reduce crossing visibility, but they do create a buffer from traffic when walking along the road.
- High, opaque property fences or walls, as in Figure 49.
- Vegetation. Overgrown bushes and large trees in the nature strip can limit visibility along the footpath and when crossing the road.
- Electricity poles.
- The bus itself or other buses at high use stops or interchanges. When people alight a bus and then attempt to cross in front of it, the bus obstructs the view of approaching traffic.

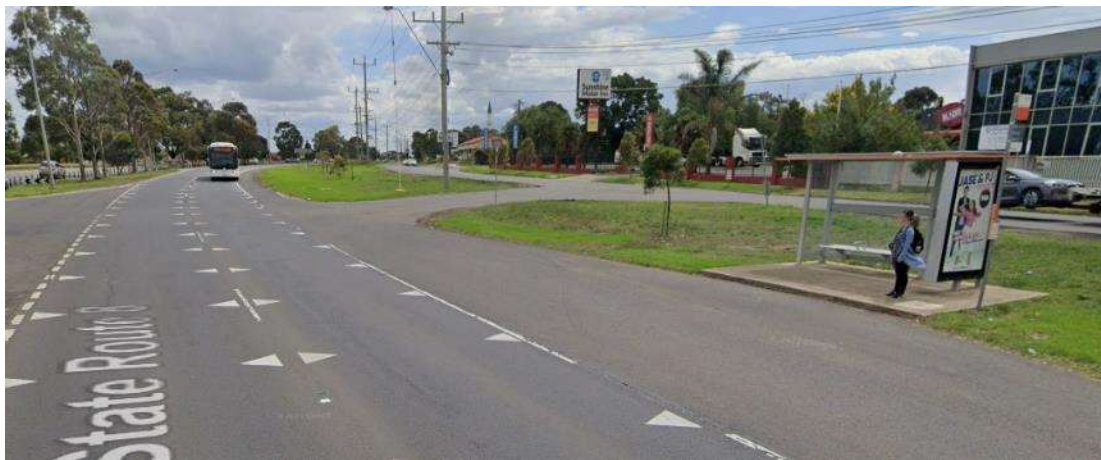
Figure 53 A person waits for bus on Ballarat Rd, Ardeer. Wire rope barriers in the median and guardrail on the opposite side of the road, in addition to the high speed and volume of traffic, make crossing directly to or from the bus stop extremely difficult and dangerous (Image source: Streetview, Google Maps, February 2020)

In another example, residents of Federation Retirement Village are so scared to cross Ballarat Road in Ardeer and Albion – an 80 km/h, five-lane arterial with turning lanes and service roads – that they catch a bus 1 km west to the nearest pedestrian crossing and another back again, simply to get across the road (Simpson, 2019).
